# febi 180417

Opel / Vauxhall Insignia A 2008 – 2017  
SAAB 9-5 (GR) 2010 - 2012

## Charger Intake Hose with quick coupling

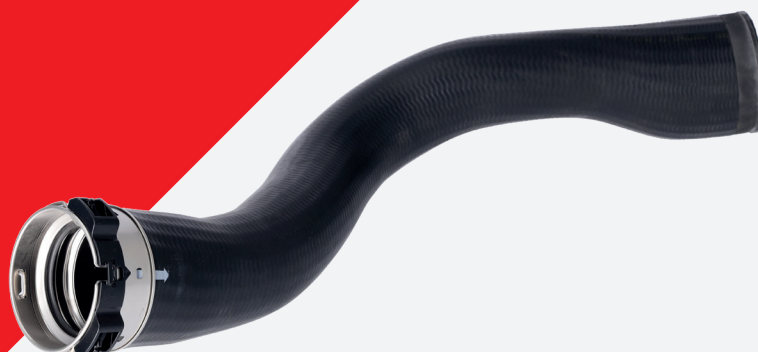
The vehicle experiencing lack of power and poor performance when accelerating under load.  
Engine management warning lamp illuminated.

Constant hot and cold operating conditions under the bonnet causes the deterioration of the turbocharger intake hose. This leads to the hose splitting, reducing the amount of boost the turbocharger can generate. As a result, the increased amount of unmetered air entering the combustion process causes the vehicle to experience a reduction in performance.

If fault code P2282 is shown, check the condition of the lower left intercooler/charger intake hose - due to this part being a known issue - and replace if necessary. febi replacement part 180417 is made to the exacting standards of the latest version of the OE hose.
